Published in:
International RILEM Conference on Materials, Systems and Structures in Civil Engineering 2016

MAGNESIUM-OXIDE BOARDS CAUSE MOISTURE DAMAGE INSIDE FACADES IN NEW DANISH BUILDINGS

Abstract

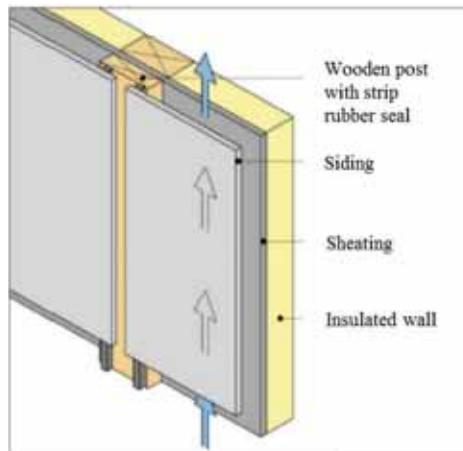
Figure 1: Sketch of a typical façade construction where a sheathing board is used as wind barrier. Adapted from [1].

In winter 2014/15, many moisture damages were observed inside ventilated facades of new or newly renovated Danish buildings. The moisture damaged facades were constructed with sheathing made of magnesium oxide boards (MgO-boards) facing the air gap behind the material used for exterior siding. MgO-boards have often been used as sheathing behind a ventilated air gap as shown in Figure 1 and Figure 3. A photo of a MgO-board is shown in Figure 2.

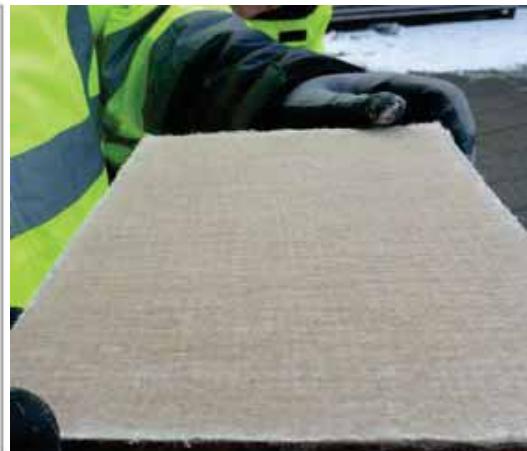
Figure 2: Photo of 8 mm thick MgO-board with a glass fibre mesh on both surfaces.

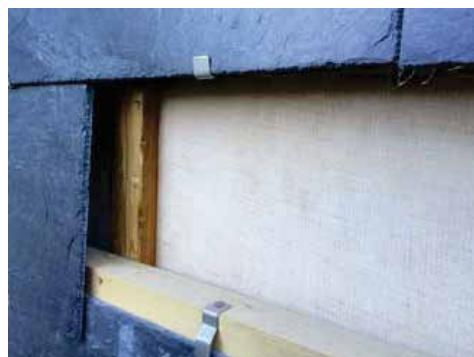
Figure 3: The MgO-board is placed facing the air gap, which is behind the siding boards made of natural slates.

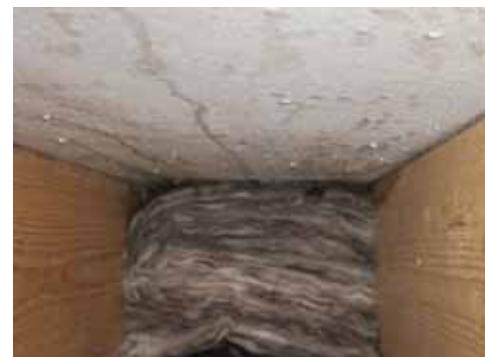
The observed damages were caused by the fact that MgO-boards absorb moisture from outside air. Water drops containing chloride ions appear on the outside of the boards – often so many that they run down the vertical boards and out via the air gap behind the siding boards (see Figures 4 and 5). The metal mountings for the MgO-boards can corrode heavily within a few years, cf. Figure 6.

Figure 4: Salty water drops on a vertical MgO-board on the side that faces the insulation filled cavity inside the wall.

For this reason, it can be stated that MgO-boards are not suited as sheathing in exterior facades or any other application where the boards are in contact with a moist climate. At RH above approximately 84% RH the MgO-boards will form drops of salty water on the surfaces, and this water will be absorbed in wooden structures in connection with boards and water absorption will increase and can lead to mould growth on wood. The MgO-board itself is also

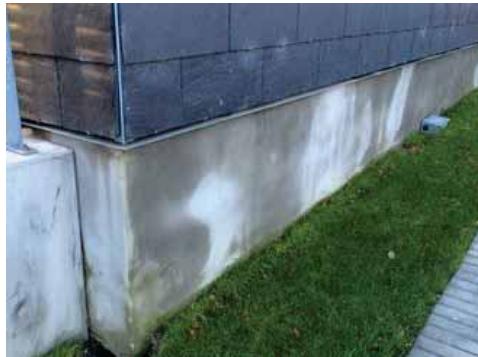
Figure 5: The water drops containing chloride ions run down the vertical MgO-boards and drain out of the wall from behind the wall's siding boards.

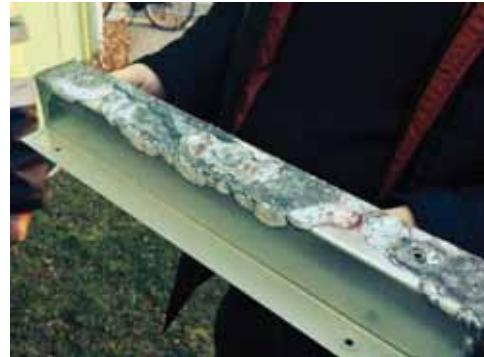
Figure 6: The zinc covering of the steel profile is corroded as a result of direct contact with salty sweat or 'tear' drops from the adjacent MgO-board.

sensitive to mould growth due to the content of organic material. Furthermore, the MgO board will itself also be disintegrated over time when it is exposed to high humidity due to the dissolution of the salts it consists of. If metal parts, such as galvanized steel, fasteners and flashings are in contact with MgO-boards, they will start to corrode within short time, leading to safety problems in the structure. Sheathing with MgO-boards are now being replaced by other types of materials in a great number of buildings in Denmark.

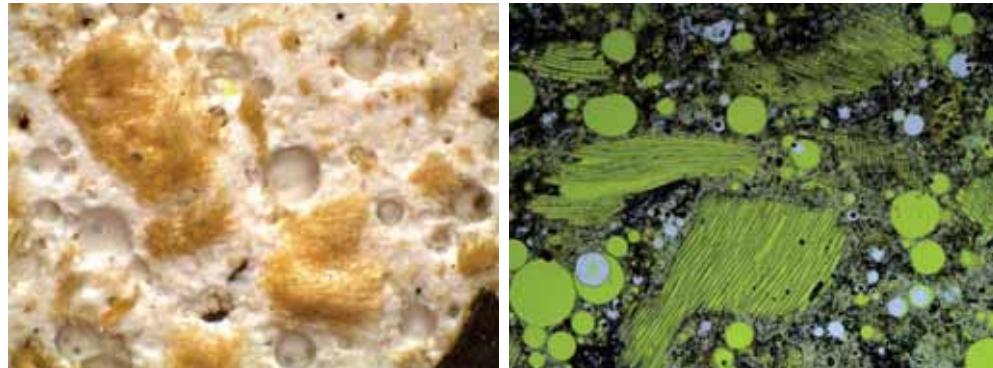
amount of very porous organic material and the many fine spherical air pores. All investigated MgO-boards have some type of fibrous reinforcement (glass fibre mesh) on the faces.

Figure 7: Cut of a MgO-board investigated in a stereo microscope at 10 times magnification.

Figure 8: Micro analysis of a thin section of a specimen at 50 times magnification.

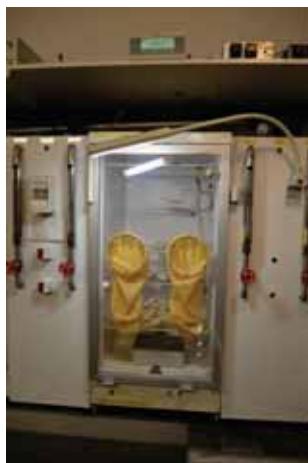
in a petri glass dish, which was placed inside a basket made of Teflon. Weighing of the baskets were performed without opening the front doors of the climate chambers, as the baskets were hung up one by one below the balance by means of a steel string. Figure 9 shows the climate chamber where the actual RH is created by mixing flow of dry air with flow of saturated air. Based on a calibrated RH-sensor the connected PID-system regulates the dry airflow and the saturated air flow for obtaining the wanted RH. In this way, the RH is created in wanted steps. Figure 10 shows the specimens in the petri glass dishes placed in the baskets. The measurements were performed after 0, 1, 2, 3, 4, 5, 7 days and after 2 and 4 weeks. The results are presented in Figures 11, 12 and 13. Indication of mould growth on specimen 4.4C was seen after 30 days of exposure to 95% RH, cf. Figure 14.

Figure 9: The climate chamber.

Subsequent measurements of absorption and desorption were performed for the same four specimens that were analysed for initial moisture absorption at 35% RH and 80% RH, i.e. the initial dry masses were known. The climate chamber used is shown in Figure 9. Desorption was measured for specimens 3.1B, 3.2B, 4.4B and 4.7B, which originally were used for determination of initial moisture absorption at 80% RH. Before starting the desorption runs, the humidity of the climate chamber was increased from 80% RH to 92% RH in steps of 2% RH with the purpose of finding the level of RH at which the specimens began to form drops (i.e. sweating or ‘crying’) on the surface. We knew from the first part of the tests (at 95% RH) that specimens showed severe sweating starting after one week, while boards at 80% RH apparently did not sweat after 80 days of exposure. In view of the risk of mould growth at RH higher than 92% RH, desorption was started at this RH. Desorption points were measured from 92% RH and below.

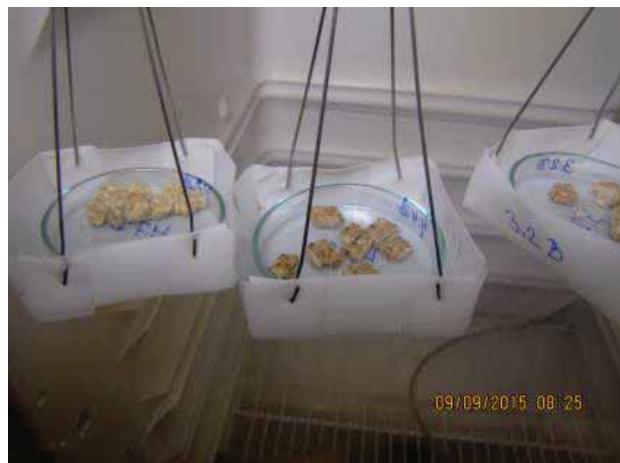
The initial moisture absorption in MgO-boards from the surrounding air was measured at three different levels of relative humidity at 23 °C: 35% RH, 80% RH and 95% RH. Before start of the moisture exposure, samples of size 5 x 4 x 3 mm were dried at 105 °C for 4 days, and cooled to room temperature. MgO-samples with a total weight of about 2 g were placed

Figure 10: Specimens in the petri glass dishes placed in baskets.

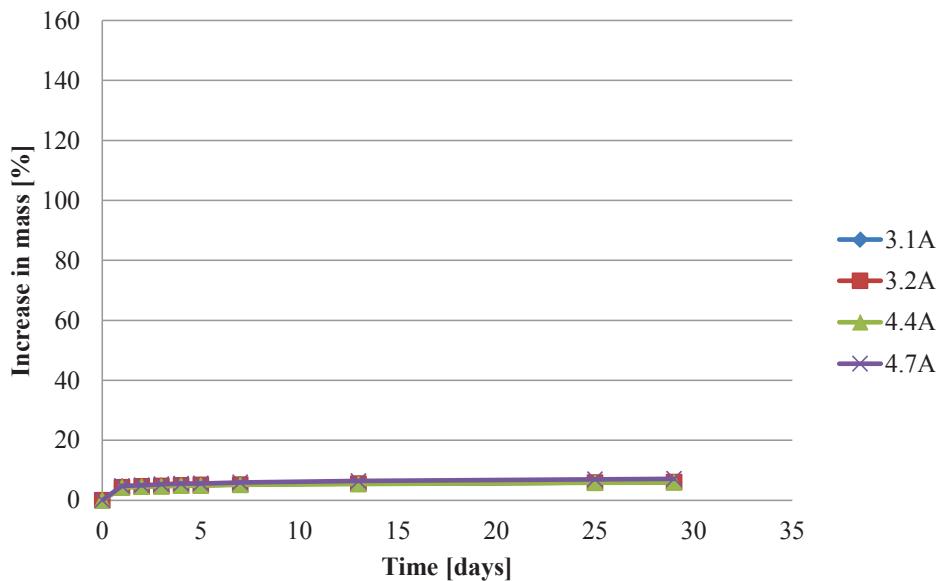
Figure 11: Course of the moisture retention at 35% RH.

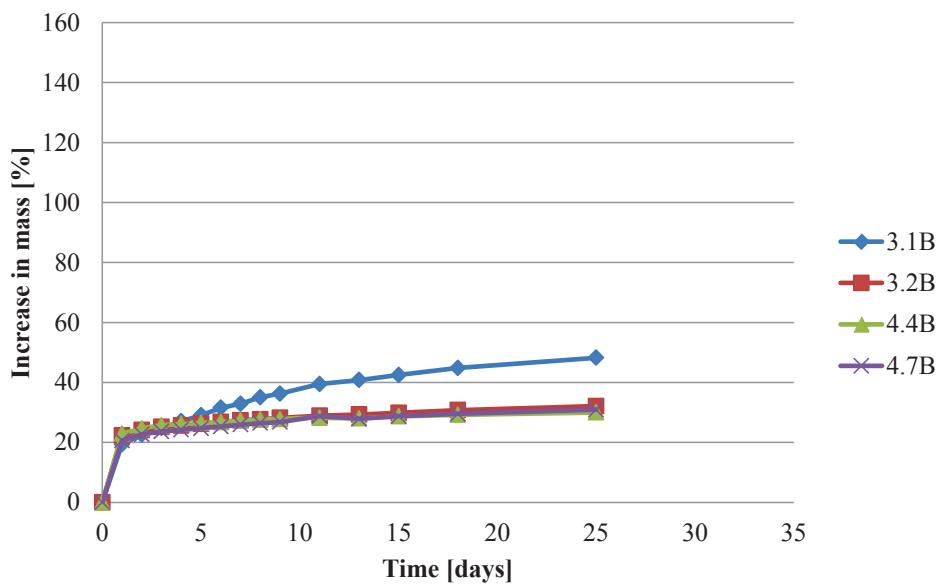
Figure 12: Course of the moisture retention at 80% RH.

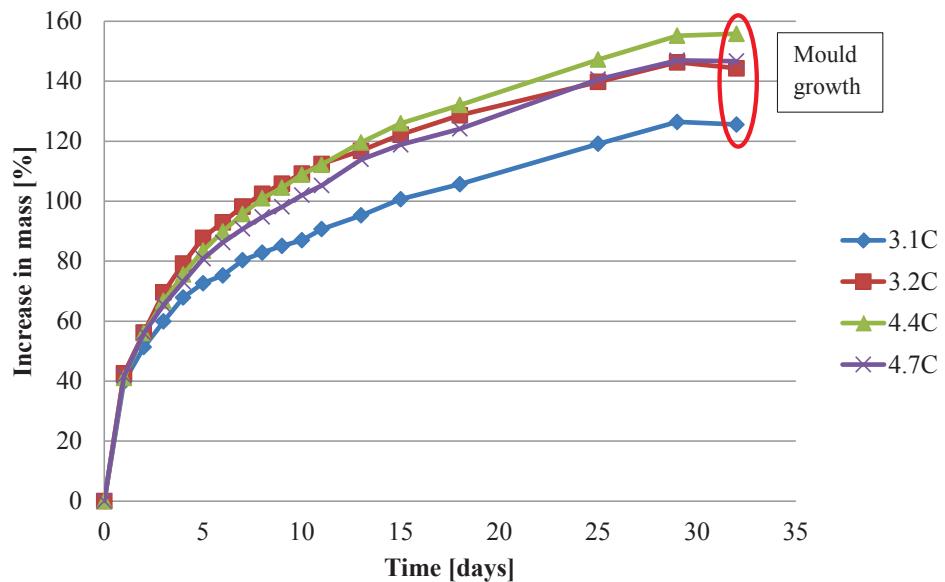
Figure 13: Course of the moisture retention at 95% RH.

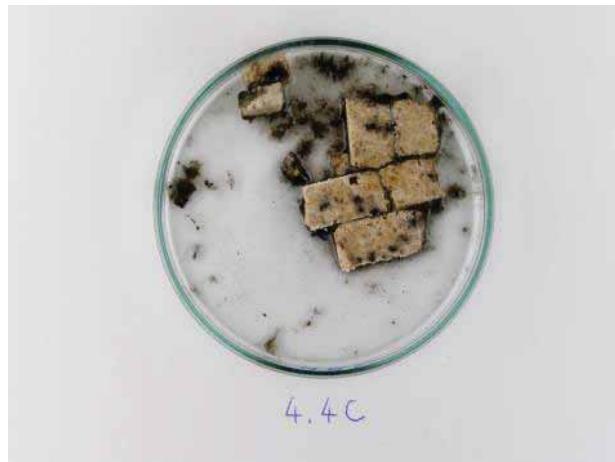
Figure 14: Indication of mould growth on specimen 4.4C after 30 days of exposure to 95% RH.

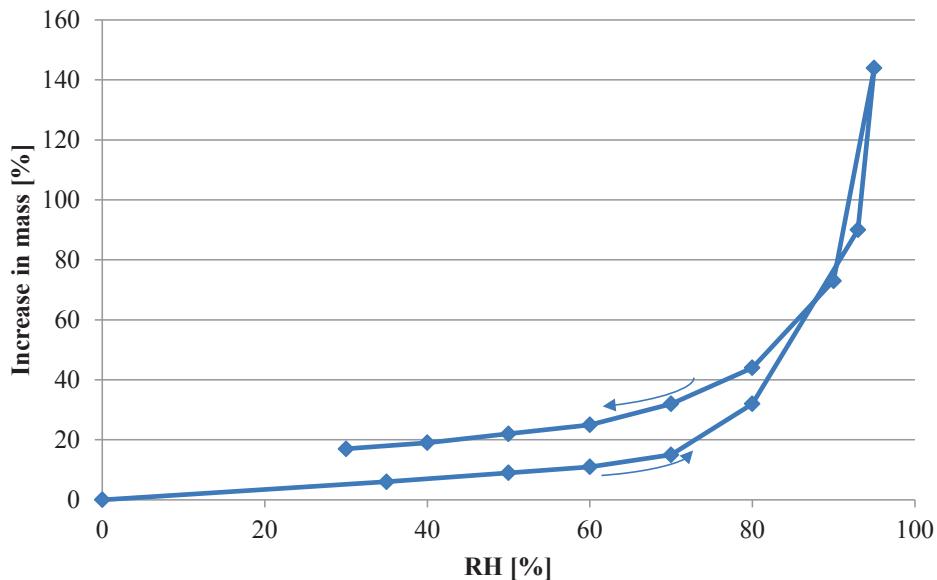
Absorption was measured for specimens that were originally used for initial moisture absorption at 35% RH. The absorption points were measured from 35% RH and up to 92% RH. An example of the results of the absorption and desorption measurements is shown in Figure 15.

Figure 15: The results of the absorption and desorption measurements for specimen 3.2.

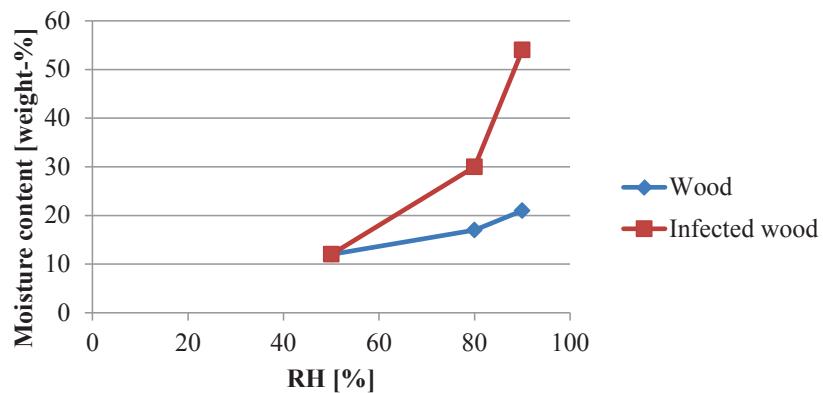
The pine wood posts supporting the adjacent MgO-boards inside the façade construction absorb the water drops ('tear' drops) from the MgO-boards. The 'tear' drops contain relatively high amounts of chloride ions. Infected wood from a post from a house, as well as non-infected wood, have been used for absorption measurements as follows: First, the infected wood and the non-infected wood pieces were conditioned to attain equilibrium at 50% RH. They were then conditioned to equilibrium at 80% RH, and finally to equilibrium at 90% RH. The absorption curves for the infected wood and the non-infected wood are shown in Figure 16.

Figure 16: The absorption curves for the infected wood and the non-infected wood.
